## HISTORIC DISTRICT REVIEW BOARD WORK SESSION AGENDA

**Agenda Item:** APPLICATION FOR AN ALTERATION, HDRB #25-009, to consider an application for a Certificate of Appropriateness for alterations that include replacement siding, porch columns and railings, windows, entry doors, roof eaves, and asphalt shingle roofing at the single-family residential building located at 820 Locust Street, Herndon, Virginia

**Meeting Date:** October 1, 2025

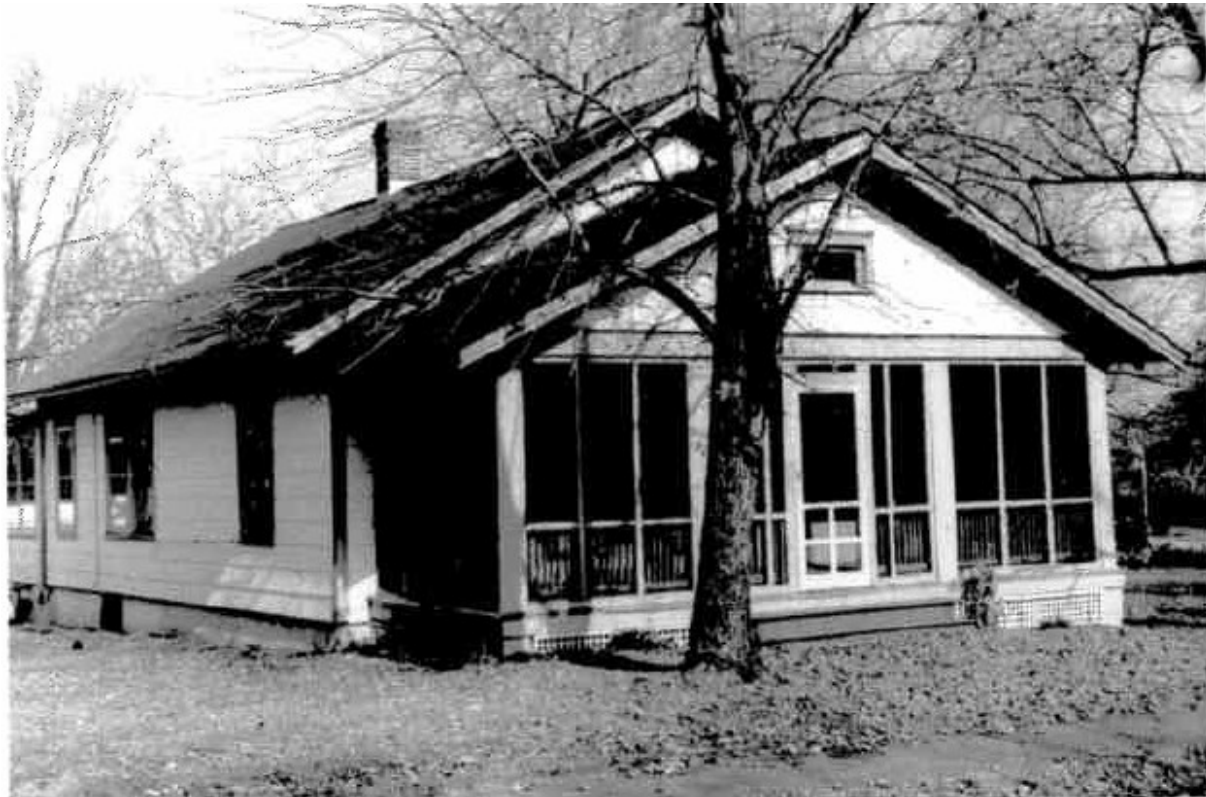
*Figure 1: 1987 architectural survey photograph showing the porch prior to circa 1998 alteration. Source: Town of Herndon*

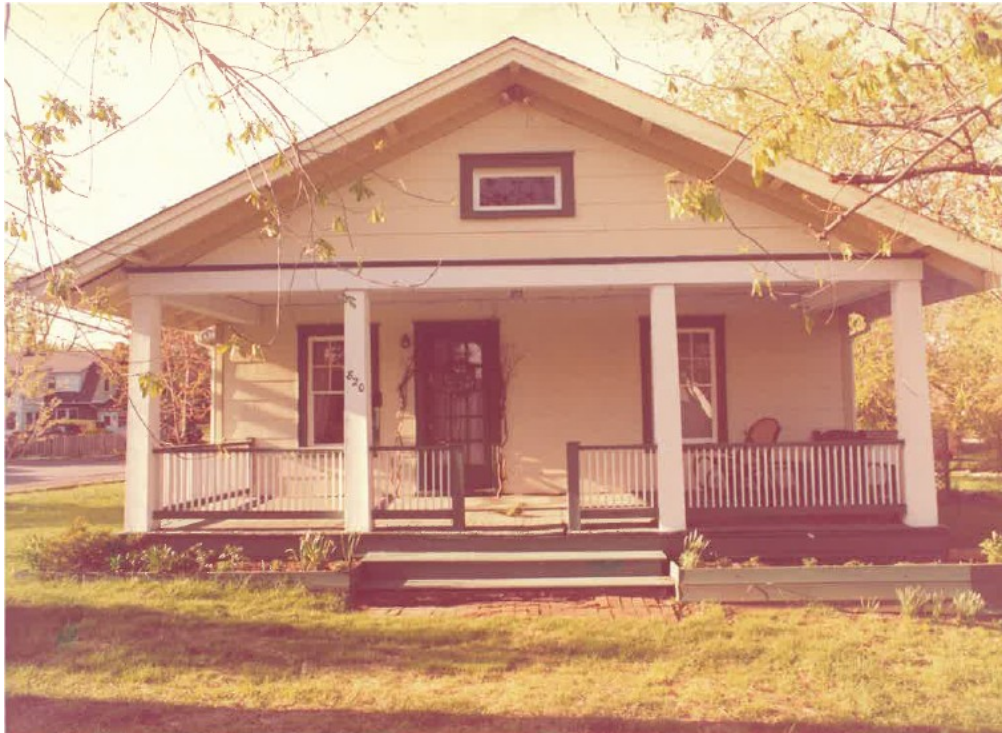
*Figure 2: Façade (South Elevation) prior to second floor addition completed according to HPRB 97-7, 1997. Note the alteration to the front porch that occurred between 1987 and 1997.*

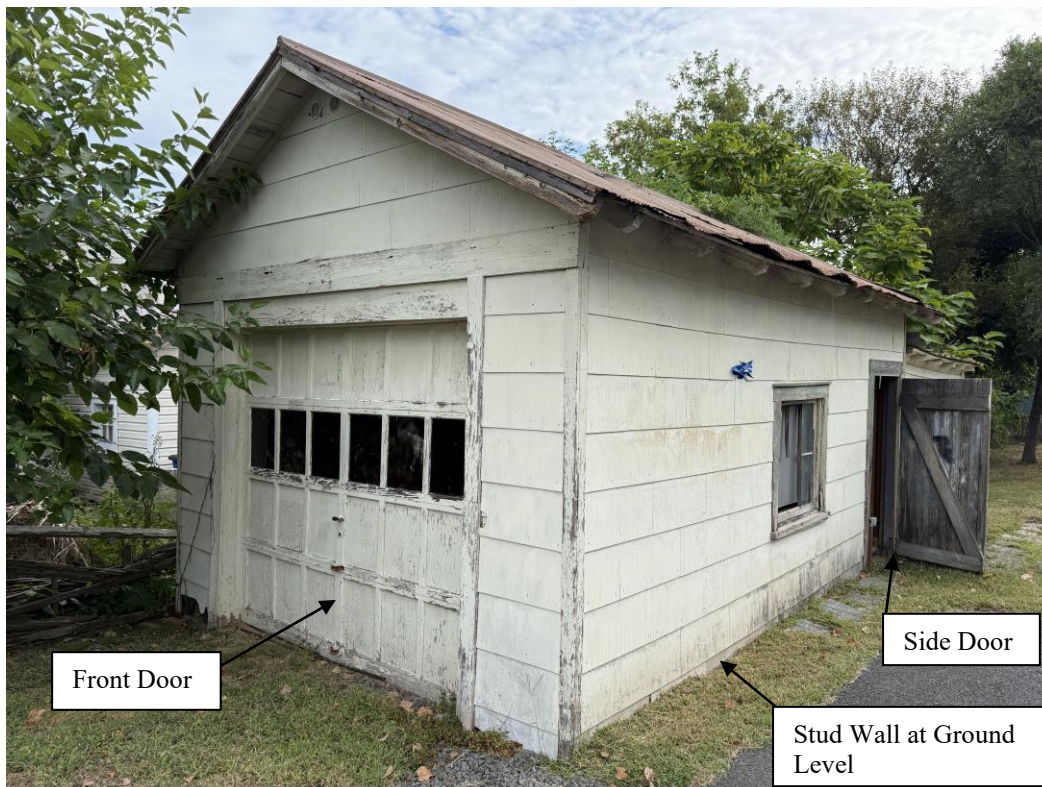
Front of Garage  
Figure 1

The existing garage/storage shed is a one-story structure, built in 1925, as shown in Figure 1 & 2.

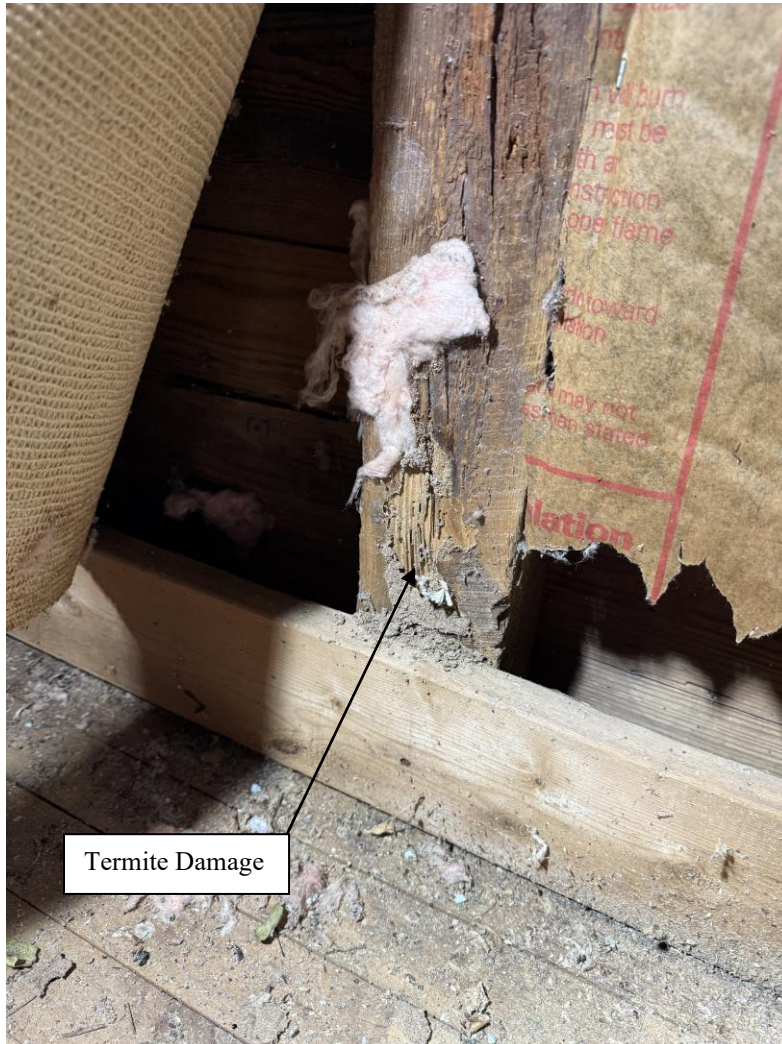
Termite Damage in Wall Stud

Termite damage was observed on wood stud in the exterior wall of the garage, as seen in Figure 5.

Based on the existing structural conditions observed, we recommend that a higher-level slab and new footings be installed, and all existing stud walls be replaced. Removal of the existing foundation, stud walls and roof framing and construction of an entirely new foundation and structure are necessary to meet the current building code. We believe any effort to save the garage/shed structure or part of it would be impractical and uneconomical.

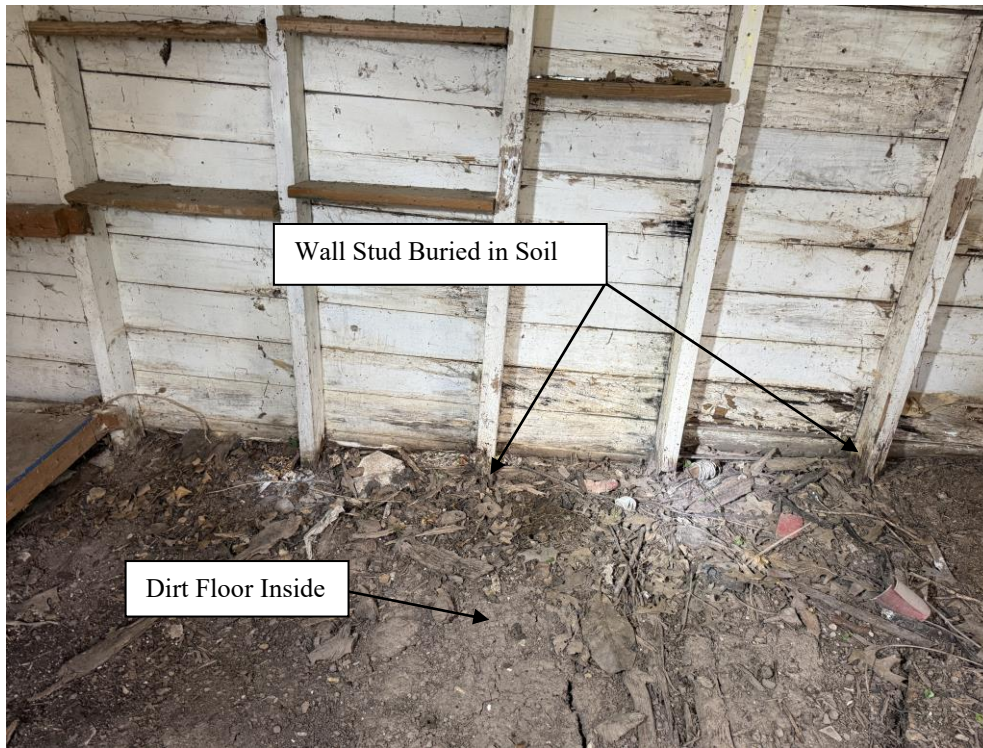
Storage Shed Stud Wall  
Figure 6

The exterior stud wall of the storage shed is noticed buried in soil, as shown in Figure 6. The bottom of wall studs has all been rotted. There is no finished material on floor and dirt has been used as the floor.
