HISTORIC DISTRICT REVIEW BOARD WORK SESSION AGENDA

Agenda Item: APPLICATION FOR AN ALTERATION, HDRB #26-002, 879 Station Street, Herndon, Virginia, to consider an application for a Certificate of Appropriateness to replace windows on the building located on the west side on Station Street, north of the intersection with Center Street

STAFF REPORT

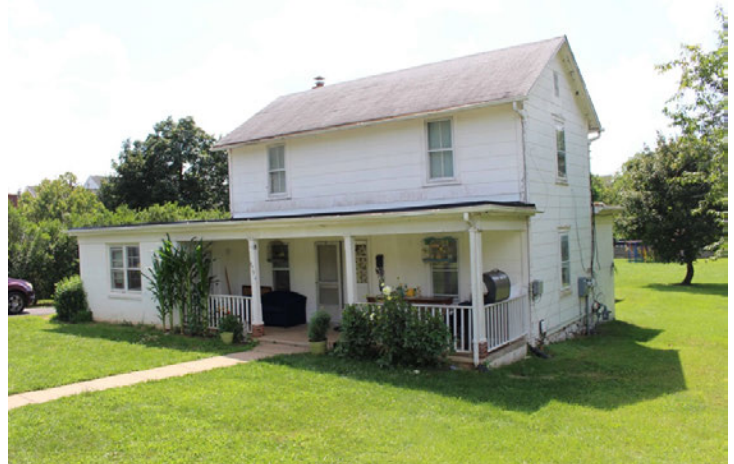
Photograph - Primary Elevation(s)

Main Entry Door:	Paneled wood door with glazed upper opening, wood surround, and screen storm door
Front Porch:	One-story, three-bay porch with flat roof. Concrete base and floor, square wood posts with chamfered edges, and railings with square profile balusters
Signs and/or Murals:	None

Vernacular Folk Victorian with much of original form, original wood windows and trim.

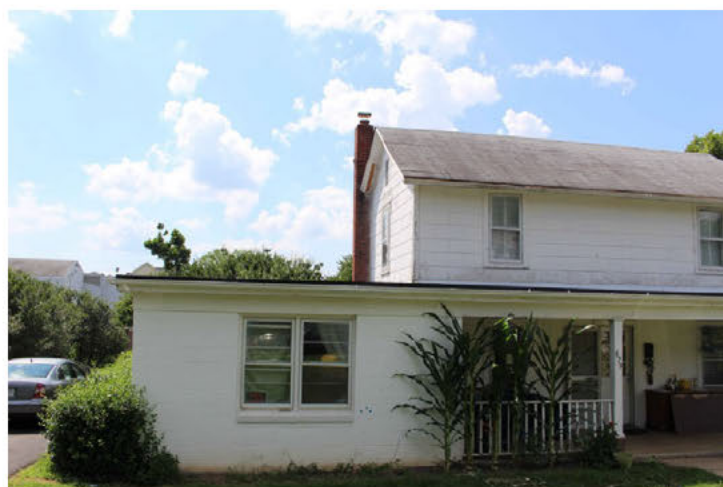
Photograph - Secondary Elevations or Details

One-story concrete block addition with flat roof, constructed circa 1953, wraps main house to front, side, and rear. Extensive replacement of cladding materials. Porch appears to have been modified, original wood windows and trim
