## HISTORIC DISTRICT REVIEW BOARD WORK SESSION AGENDA

**Agenda Item:** APPLICATION FOR AN ALTERATION, HDRB #25-009, to consider an application for a Certificate of Appropriateness for alterations that include replacement siding, porch columns and railings, windows, entry doors, roof eaves, and asphalt shingle roofing at the single-family residential building located at 820 Locust Street, Herndon, Virginia

**Meeting Date:** October 1, 2025

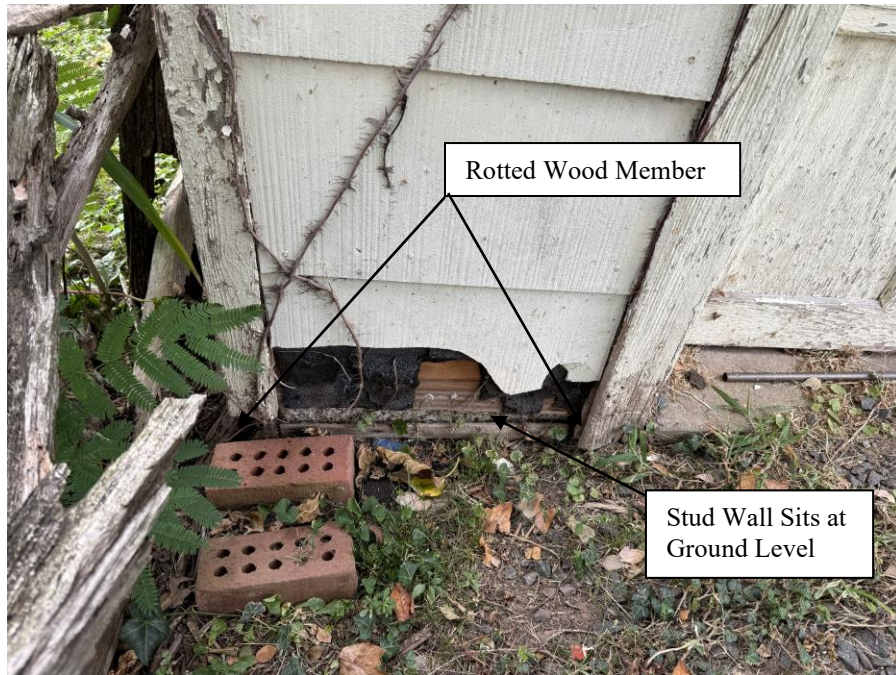
Wall Panel Beside the Garage Door  
Figure 3

The exterior wall of the garage was found sitting at the ground level, see Figure 1, 3 & 4, which does not comply with the current building code, in which, wood framed stud wall is required to be installed 6" minimum above finished grade. As a result of the existing condition, the wood members at the bottom of the exterior wall are rotten, as seen in Figure 3 & 4.

*Based on the existing structural conditions observed, we recommend that a higher-level slab and new footings be installed, and all existing stud walls be replaced. Removal of the existing foundation, stud walls and roof framing and construction of an entirely new foundation and structure are necessary to meet the current building code. We believe any effort to save the garage/shed structure or part of it would be impractical and uneconomical.*

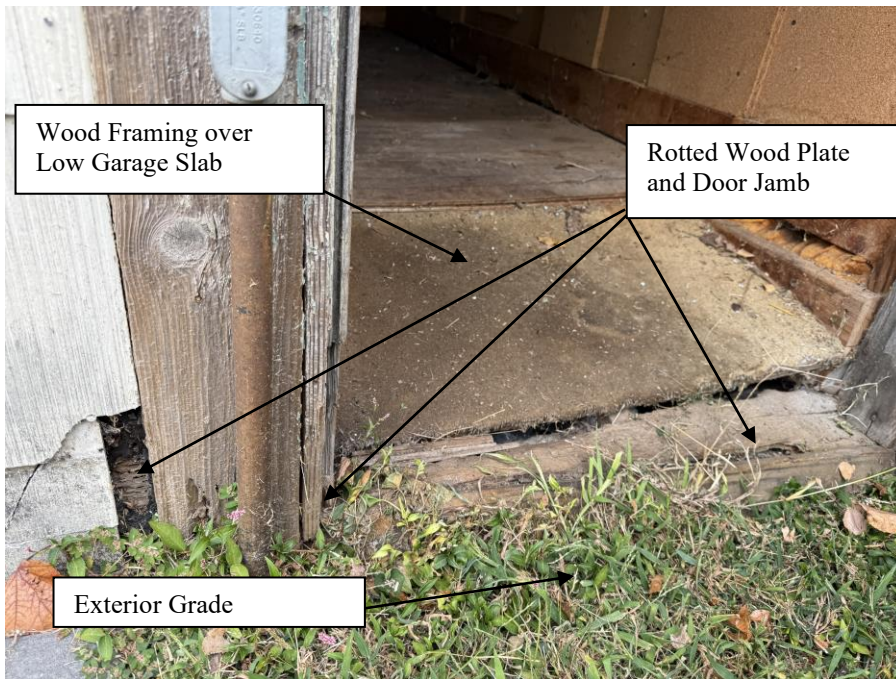
Garage Side Door  
Figure 4

In Figure 4, the garage slab is found lower than the exterior grade, over build floor framing was installed to elevate the floor above grade.
