## HISTORIC DISTRICT REVIEW BOARD MEETING AGENDA

- a. **APPLICATION FOR DEMOLITION, HDRB #23-001**, to consider an application for a Certificate of Appropriateness for the demolition of two contributing structures, a two-story house and a single-story accessory structure at 725 Elden Street, Herndon Virginia, located west of the intersection of Elden Street and Lynn Street. The subject property is further identified as Fairfax County Tax Map 0162 02 0091, is zoned as CC (Central Commercial District) and consists of 16,159 square feet of land area. Owner/Applicant: Kathryn Adams, Adams Herndon Holdings LLC. Agent: David Kipper, Golden Real Estate Services.

This case proposes to demolish a historic house and historic outbuilding within the Town of Herndon Historic District. At this time the applicant is not proposing any replacement uses or structures for the property. Evaluation on whether demolition of historic resources is appropriate is based on direction in the Historic District Guidelines and standards within the Zoning Ordinance. This report analyzes this case against those guidelines and standards.

**REPORT OF  
STRUCTURAL SURVEY AND EVALUATION  
FOR  
725 ELDEN STREET  
H

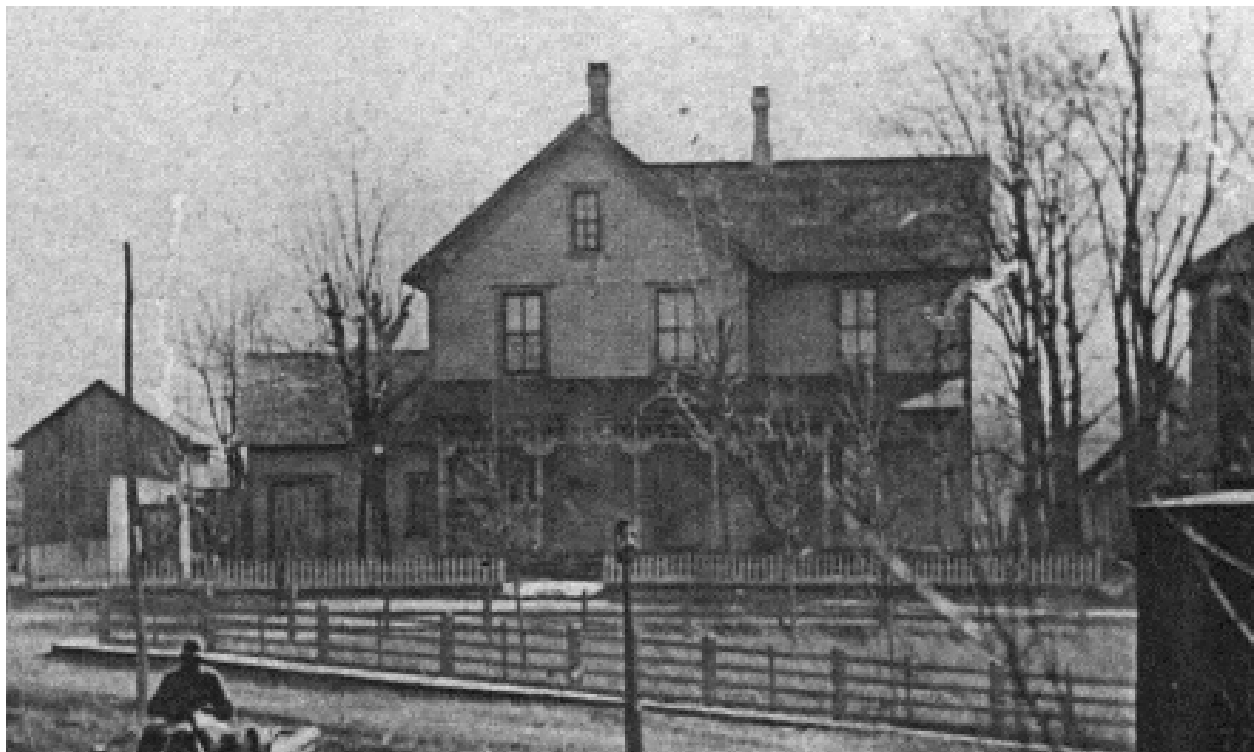
The historic house at 725 Elden Street is constructed of a wood frame with two-stories, and an attic and partial basement. There have been changes and alterations over time as detailed below, but many of the elements that are characteristic of Folk Victorian are still prominently visible. The form of the house is T- or cross-gabled and later additions are appropriately placed to the rear of the house, allowing for the original form to be unobstructed when seen from the public right of way. The windows retain a 2-over-2 design with simple window surrounds. A narrow, 4-over-4 sash window sits in the center of the front gable, typical of many Folk Victorian houses. The cladding is aluminum lap siding and while old would not have been the original siding. In its form, the siding is an appropriate replacement with historically typical narrow reveal. It's possible, as would have been standard practice, that the original wood siding remains under the aluminum siding. The house also features green louvered fixed shutters and an asphalt shingle roof. One central chimney remains and is located at the center of the roof of the main gable. The most prominent feature of the house that has changed since its original construction is the removal of the front porch, which is shown in the historic image below.

The 725 Elden Historic Structures are the subject of this application and occupy a prominent location along Elden Street in the downtown area. Both structures (a historic house and a historic carriage house) are contributing structures within the Town of Herndon Historic District and were built during the District's period of significance. Tax records indicate that these structures were built c. 1888 by Charles Reed, a prominent member of the Herndon community who built many of the oldest buildings in the Historic District and whose family started the first funerary business in Town. The historic house faces Elden Street across from Town Hall Square. It is visible from three public rights-of-way; Lynn Street, Elden Street and the Washington & Old Dominion Regional Trail. A grade change elevates the house slightly above Elden Street which enhances its prominence especially when viewed from Town Hall and the W&OD train depot. The historic carriage house is behind the house and only partially visible on the left side of the house from those same three rights-of-way. A historic image of the house and outbuilding is provided on page 3 of this report.

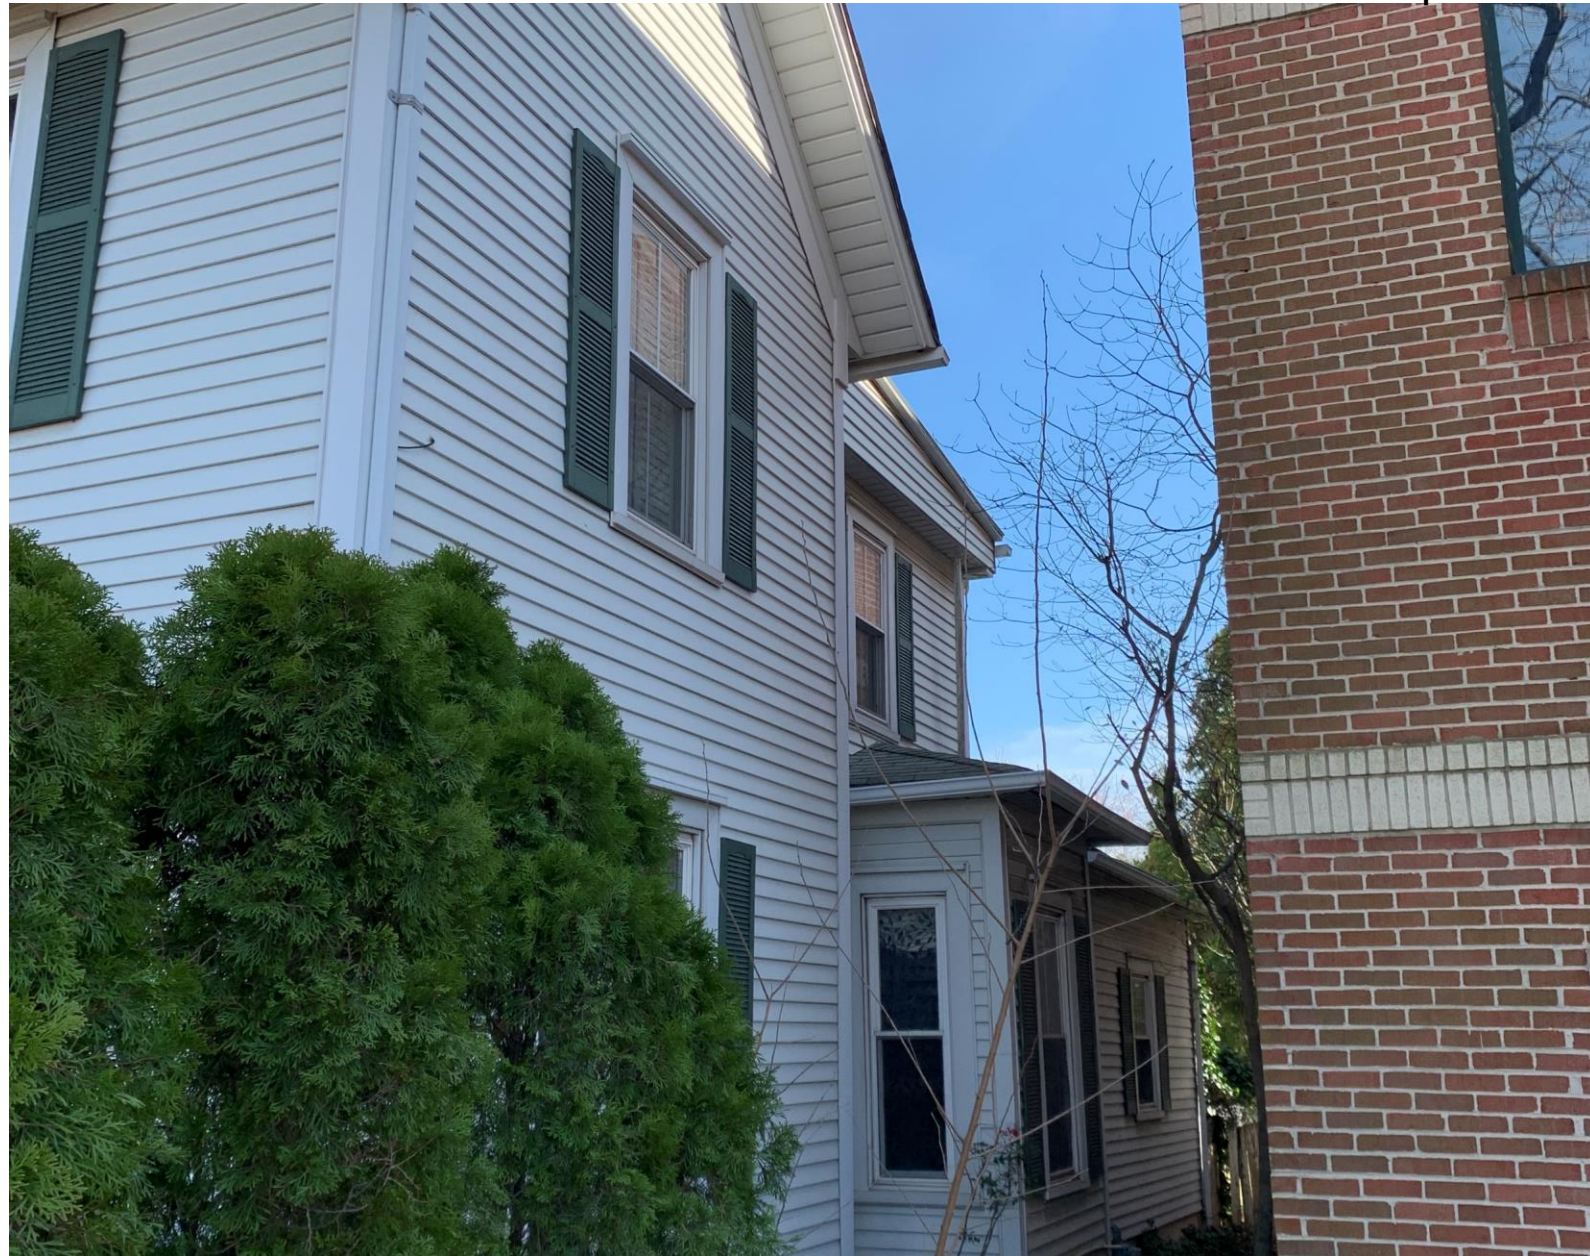
# West facing structure of 725 Elden Street

Commercial building to  
the West is ON the  
property line of 725 Elden  
Street

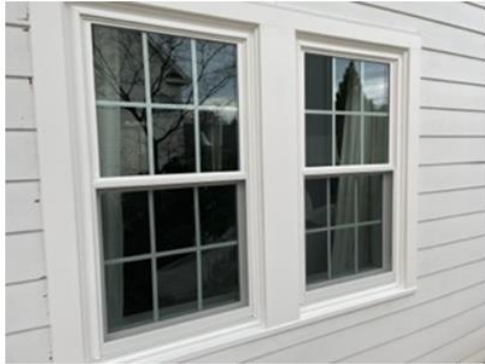
Photo below is newly installed windows on south side of house. It is very similar to the windows that were replaced but superior in quality.

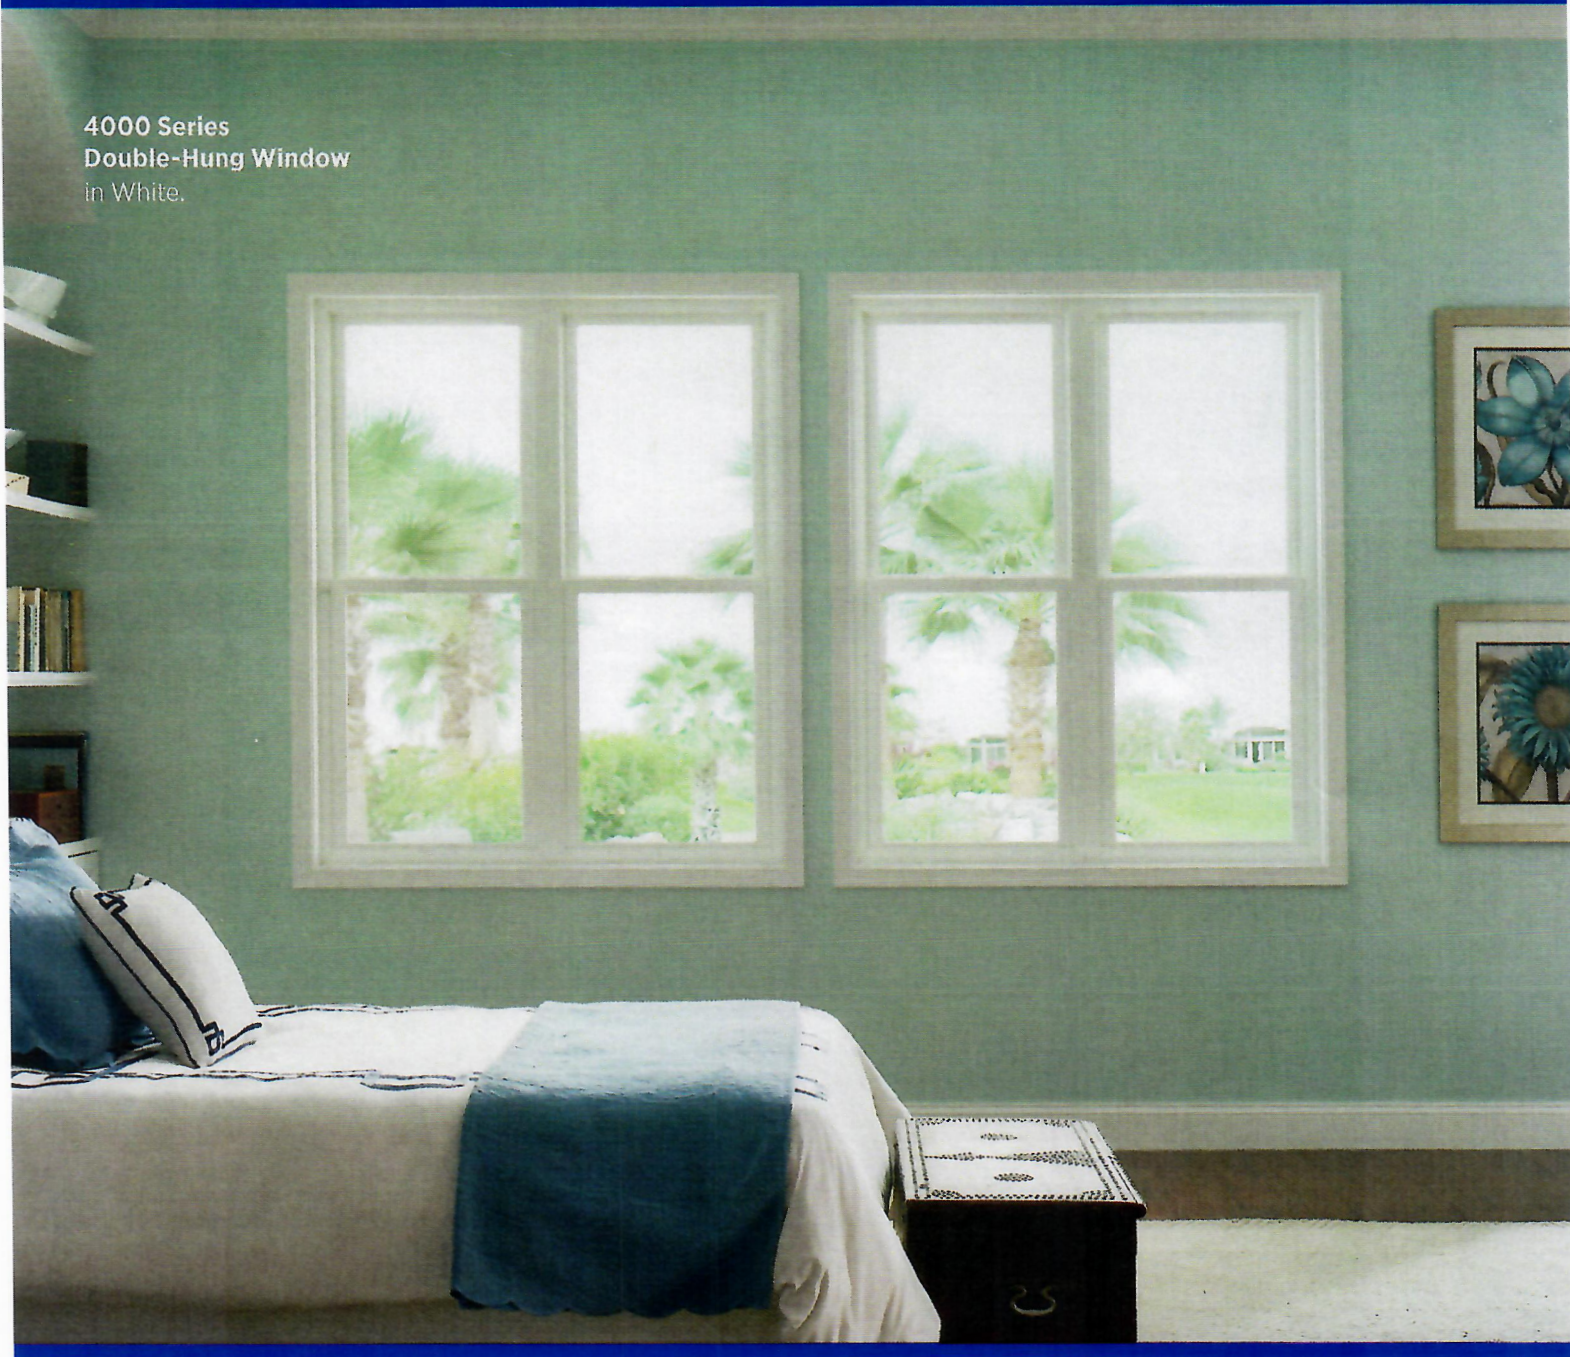
4000 Series  
Double-Hung Window  
in White.

This application proposes replacing all remaining wood windows (23 in total) and two non-wood windows with new vinyl windows. The structure contains seven newer windows that are currently vinyl which are situated on the addition or newer portions of the house. The existing vinyl windows are not proposed to be replaced. The applicant stated that the proposed replacement windows would not alter the size of the window openings created by the removal of the original wood windows but did not provide specifics regarding the size, light division, or specific design of the proposed windows. The proposed replacement windows are Window World double-hung vinyl windows.

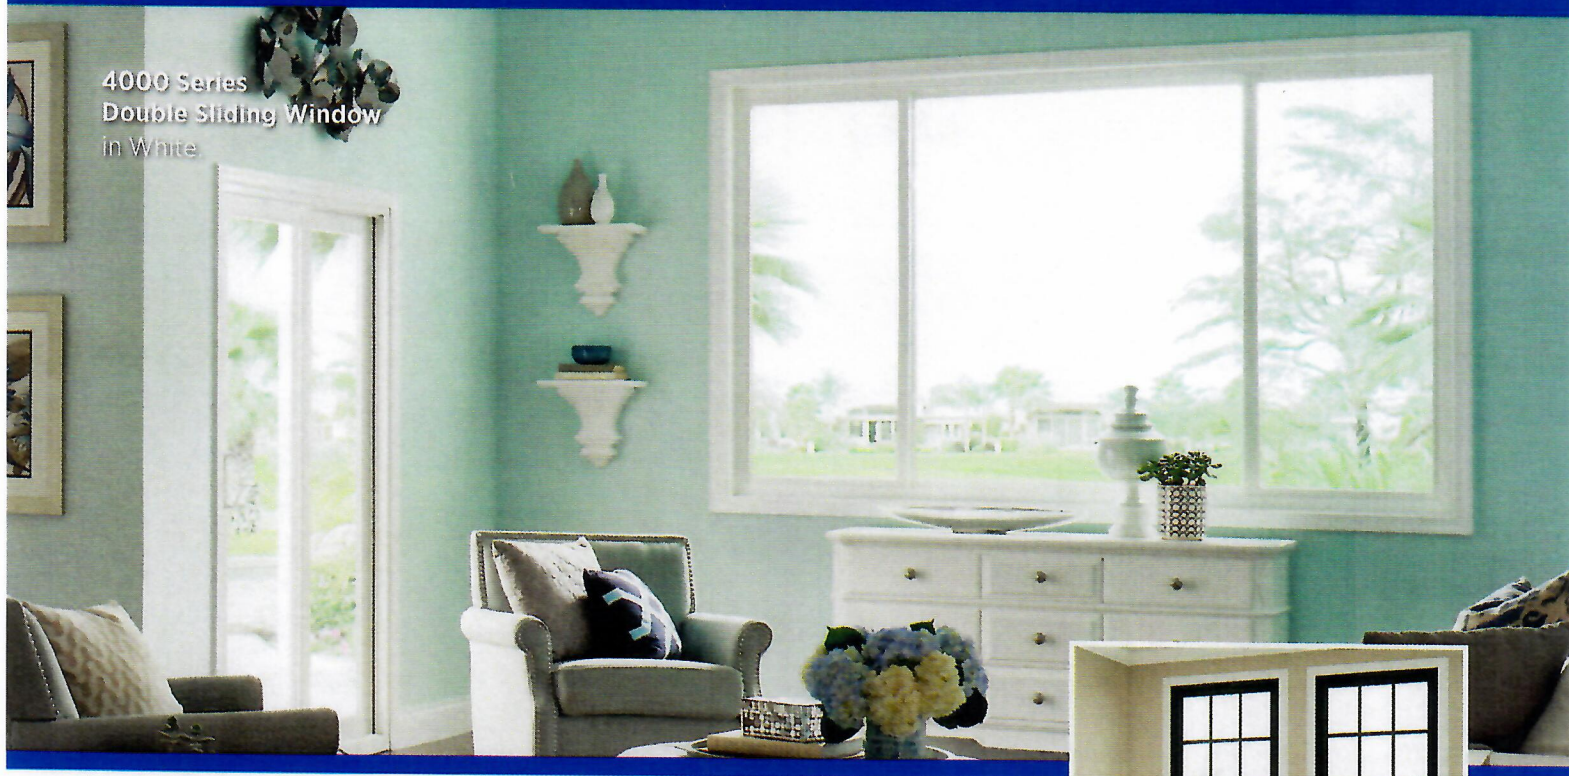
4000 Series  
Double Sliding Window  
In White

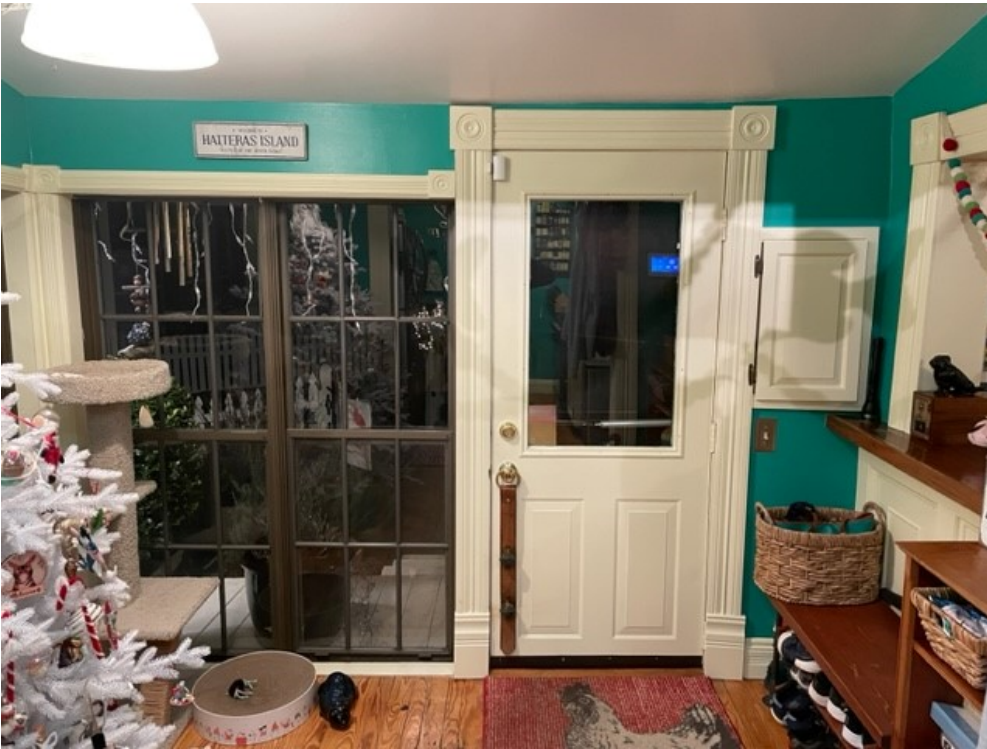
1. To the right of the side door is the electrical panel covered by a hinged wood door.

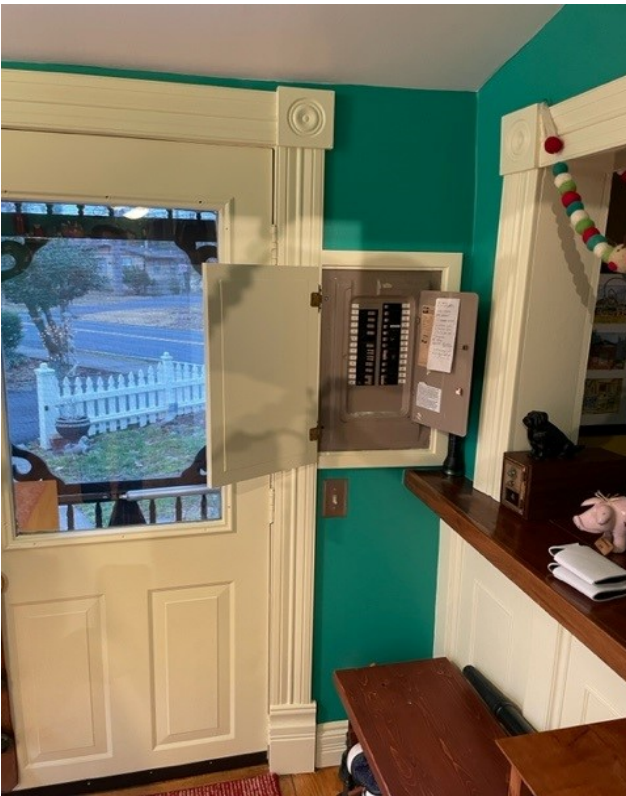
This is the electrical panel behind the hinged door.

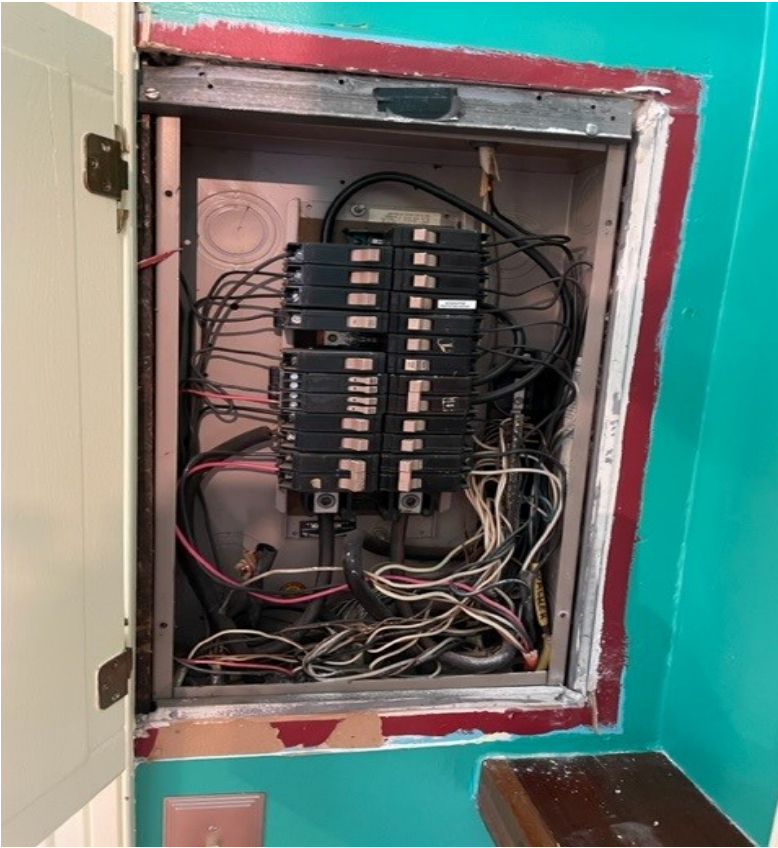
Horrible look inside of the panel box. Appears that a non professional installed this wiring. Not code compliant

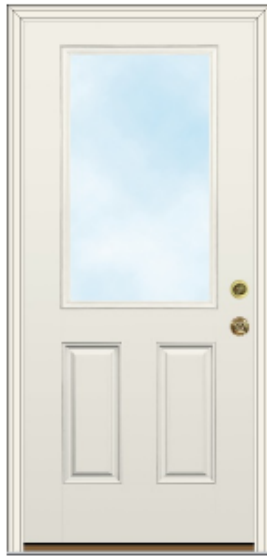
OUTSIDE VIEW

Heritage Smooth Fiberglass Entry Door with Clear Glass

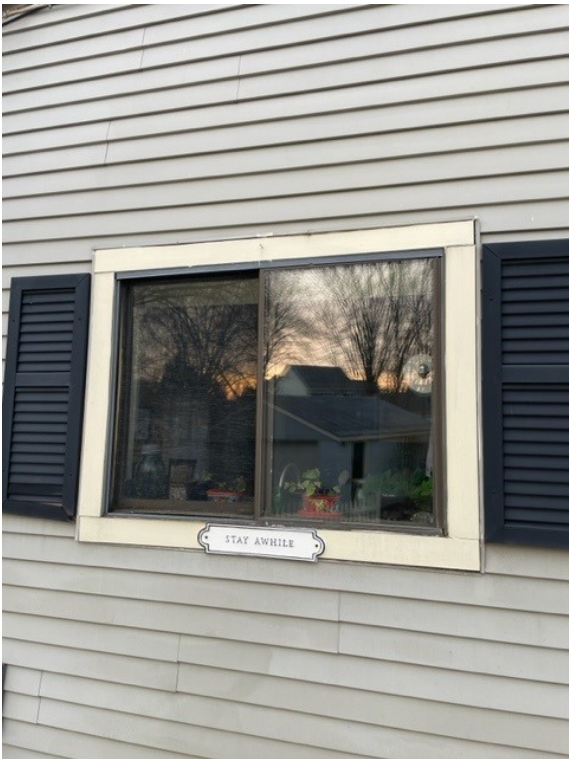
3. Kitchen Window: Rear of house

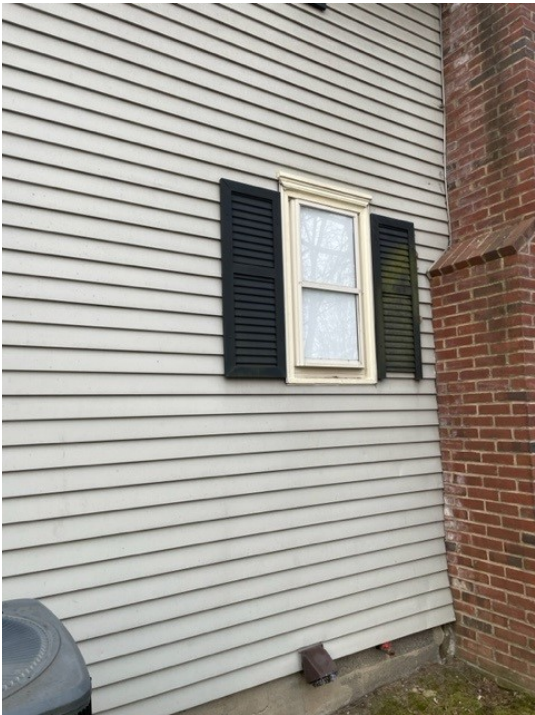
4. Bathroom Window: Side of house

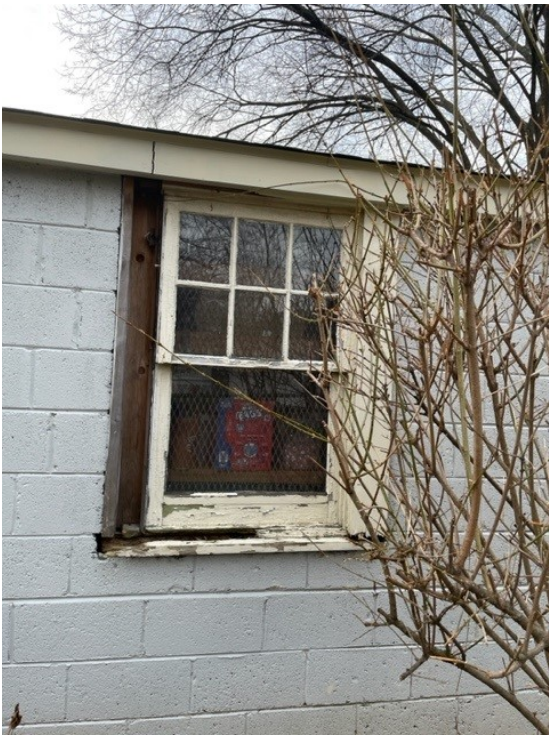
5. Garage Window: Left Side.

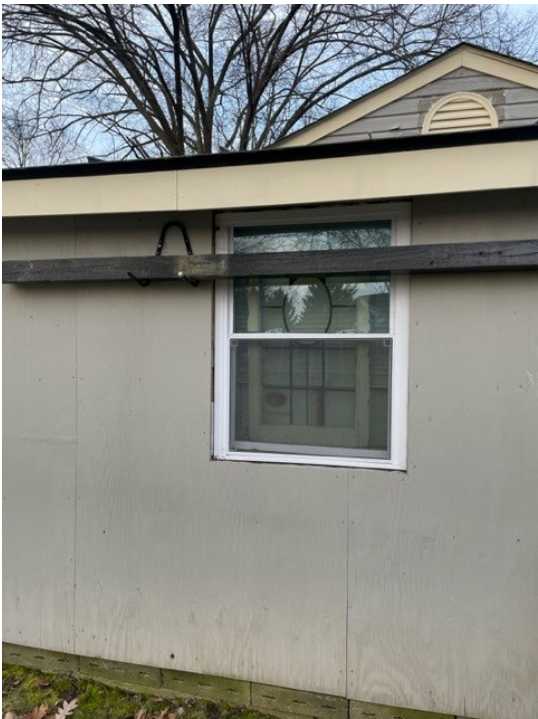
6. Garage Window: Rear

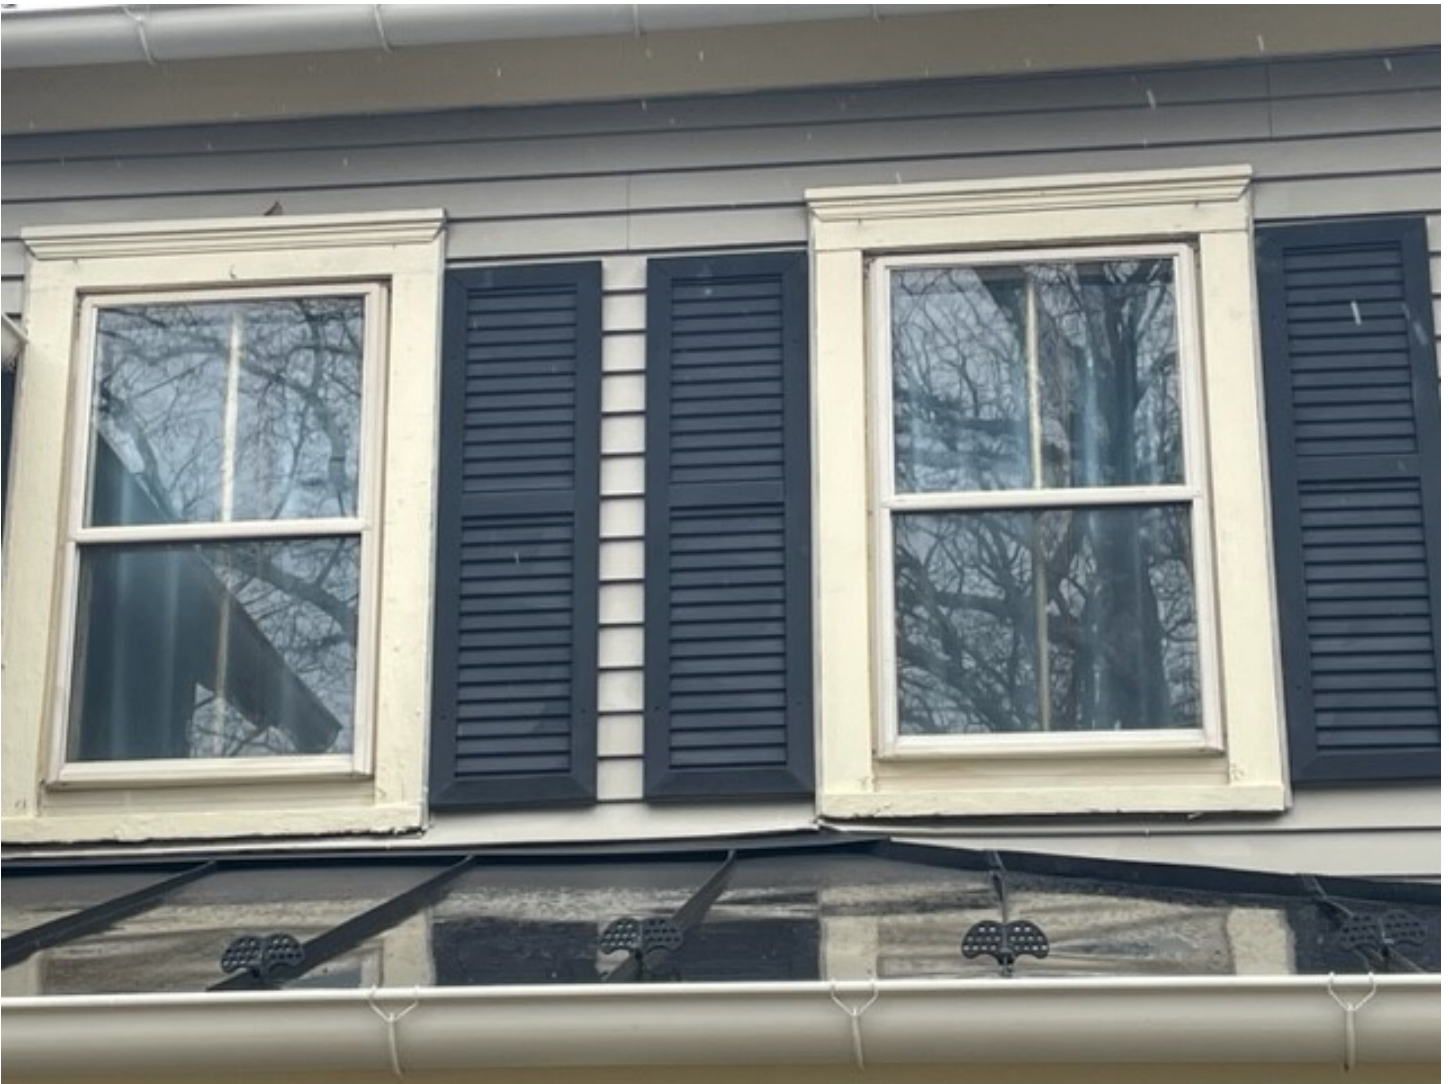
Original windows in home. The goal is to match this design for the new windows.
